## TIME-OF-TRAVEL IN CLEAR CREEK

## VII. STREAM INFORMATION BY GEOGRAPHIC REGION

### Main Stem to West Fork

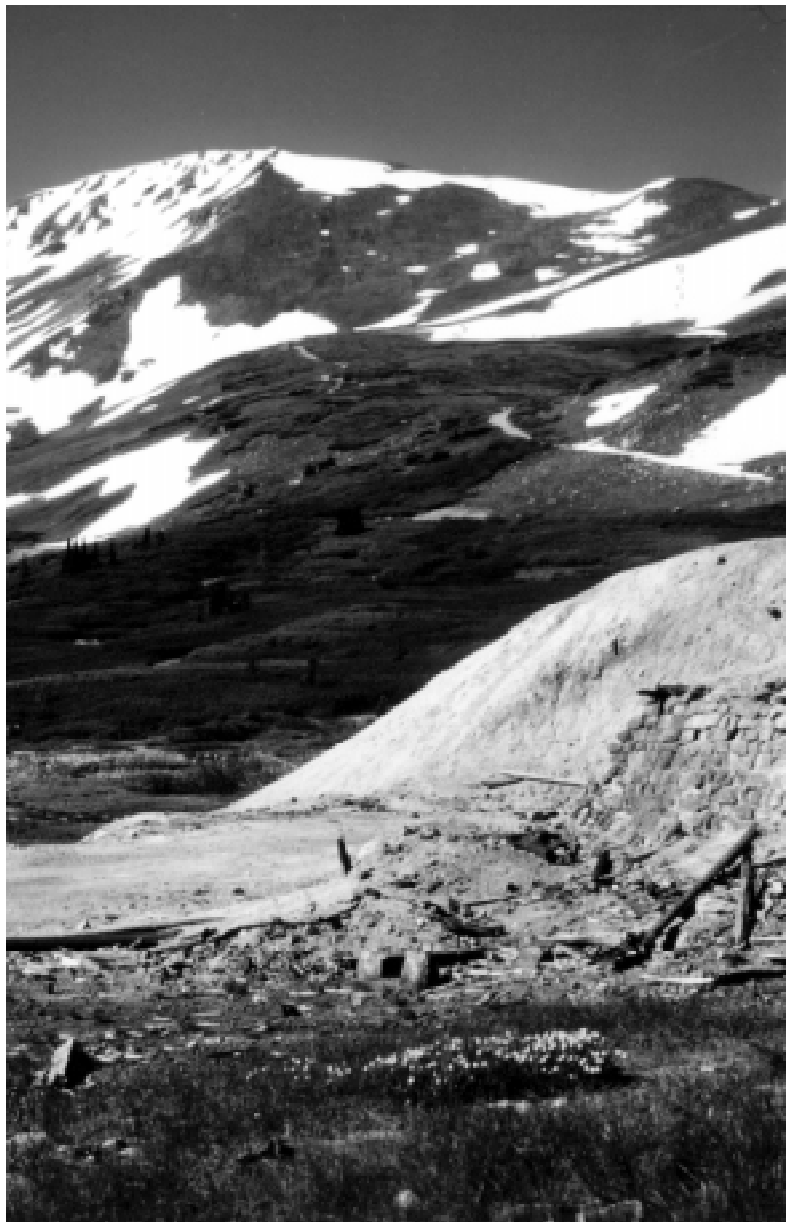
### **THE WALDORF MINE**

***One of many old mining sites in the watershed.***

**CHALLENGE:** *The Waldorf mine, situated on Leavenworth Creek, would seemingly be a simple mine site to clean up. From a construction standpoint, this is true. What makes the cleanup of the Waldorf and other similar orphan mine sites difficult is the complex network of land ownership so prevalent in the Clear Creek watershed and elsewhere in the state. Mining claims, which are normally no larger than 300 feet by 1500 feet,*

*cover a good share of the watershed leaving behind pie-like slices of federal land to be administered by the USDA Forest Service. The Waldorf mine has a mix of unpatented mine claims, private land, and USDA Forest Service-managed land. This complicates issues of access and responsibility for cleanup.*

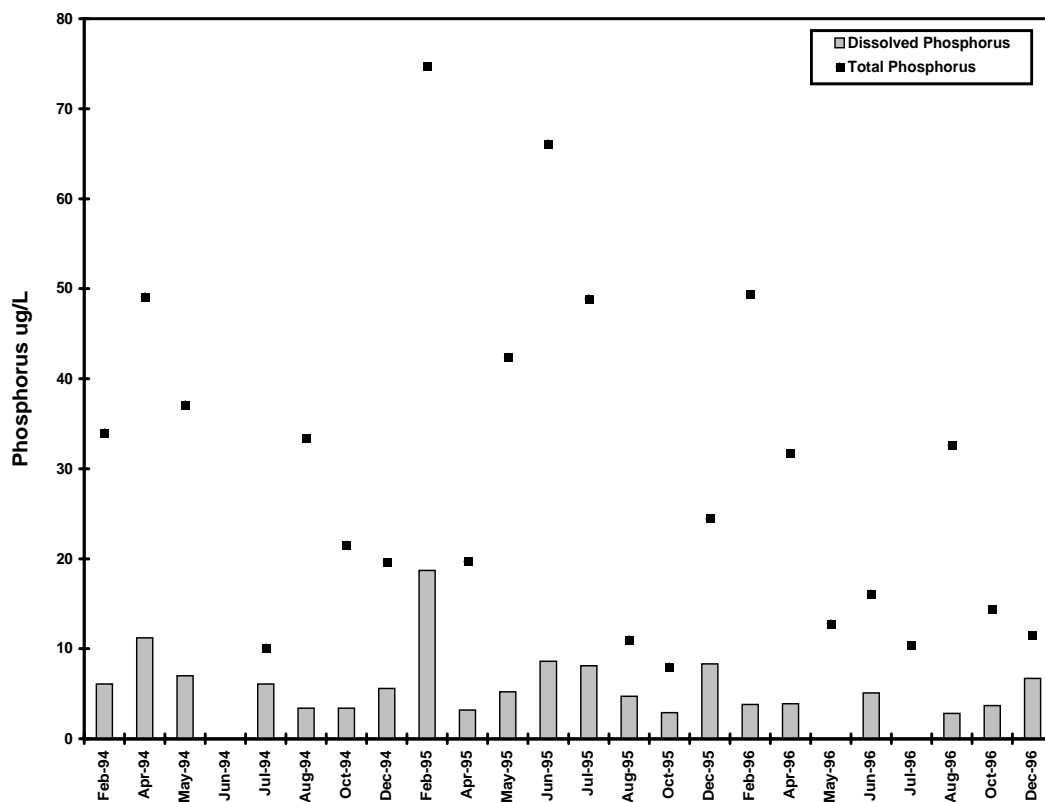
## PHOSPHORUS IN CLEAR CREEK DOWNSTREAM OF IDAHO SPRINGS

This graph shows dissolved and total phosphorus at monitoring station CC-40, which is located on Clear Creek downstream of the Idaho Springs wastewater treatment plant. The nutrient monitoring is being conducted by the Upper Clear Creek Watershed Association and the Standley Lake Cities. There is no state stream standard for phosphorus on Clear Creek.
